Quinquennial Inspection of Hatherleigh's St John the Baptist's Church

Diocese: Exeter
Archdeaconry: Totnes
Deanery: Okehampton
Church: St John the Baptist
Parish: Hatherleigh

Date of Inspection: 22 February 2021
Inspector: Sam Percival
Company: Building Conservation Services
Address: Canns Down, Beaford Devon, EX19 8AD

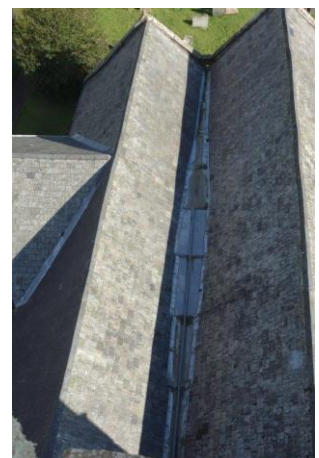
- **Component:** South and north aisle lead valleys.
- **Description:** Both valleys dressed with lead rising to the centre and falling to the east and west.
- **Condition:** Small asphalt repair to the north aisle valley and some mastic filler between a drip lap. No internal leaks noted or reported. Branches dropped by jackdaws nesting in the tower had accumulated in both valleys closest to the base of the tower.
- **Repair Needed:** Clear branches and other debris from base of tower.

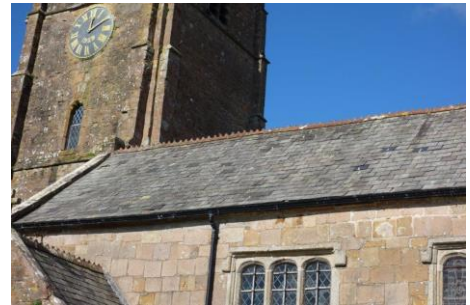
6.3

- **Component:** South and north aisle roofs
- **Description:** Natural slate roof with lead soakers and flashings to parapet upstands.
- **Condition:** To the south aisle south slope alone there were over 20 slates fixed in places by tingles, 3 slipped slates, 2 slates missing and 9 damaged. The north aisle north slope had over 2 slipped slates and 4 damaged slates and many secured with tingles. The hidden slopes appeared to be in better shape with less missing and slipped slates visible in these areas. It is probably that the nail fixings are beginning to corrode and for this reason dislodged slates will become an increasing concern. The southern slope of the south aisle being the most exposed area and the area to which attention ought to turn first.

- **Repair Needed:** Continued regular reinstatement of missing, slipped and broken slate required.
- **Repair Needed:** In the longer term re-laying the slate roofs should now be planned for, starting with the southern aisle, south facing slope.

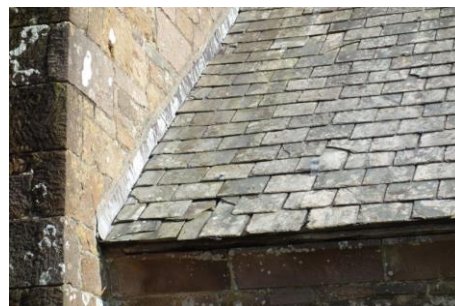
6.4

- **Component:** North transept roof.
- **Description:** Natural Slate roof, dark plain ridge tiles, lead soakers and flashings to parapet upstands.
- **Condition:** 1 damaged slate, 1 missing slates, 7+ refixed with tingles, otherwise reasonable.
- **Repair Needed:** Replace damaged and missing slates.

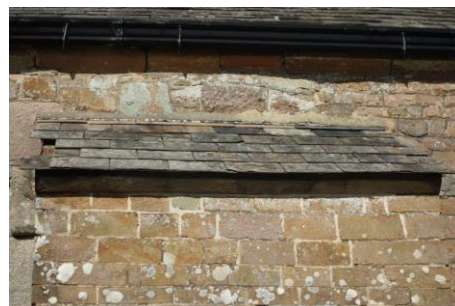
- **Component:** Porch Roof.
- **Description:** Natural Slate roof, red terracotta cusped ridged tiles, lead soakers and flashings to parapet upstands.
- **Condition:** 13+ damaged slates, 4+ missing slates, 27+ re-fixed with tingles. Remained largely dry inside.
- **Repair Needed:** The re-fixing of the slate roof over the porch should now be planned for. The existing slates can be re-used and matching reclaimed slates acquired to make up for missing and damaged slates.

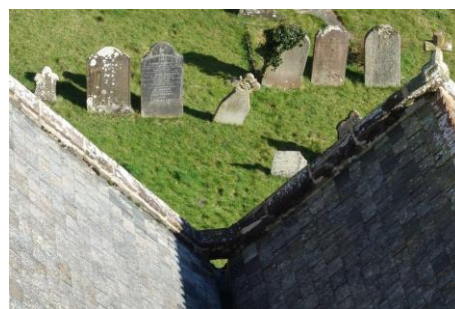
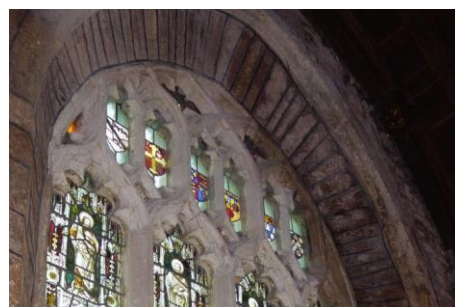
- **Component:** South aisle eastern parapet.
- **Description:** Parapet coping stones bedded on mortar.
- **Condition:** Some of the mortar joints had been re-pointed as previously recommended and the fractured second stone from the apex (north side) filled with mortar. Many open mortar joints remained and some of the repointing work appeared to be breaking down. There still appeared to be some water ingress migrating down in to the internal window soffit from the wall and parapet above.
- **Repair Needed:** The parapet coping stones would benefit from a comprehensive programme of repointing and repair works as part of a wider programme of works to include the eastern gable walls.

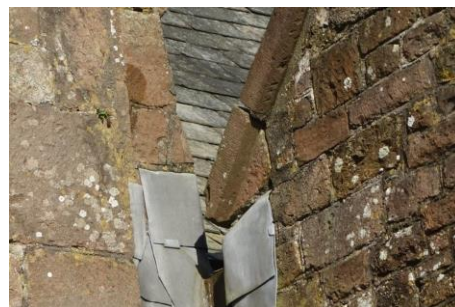
- **Component:** South aisle western parapet.
- **Description:** Parapet coping stones bedded on mortar.
- **Condition:** Loose parapet coping stone adjacent valley outlet.
- **Repair Needed:** Reset coping stone in lime mortar.

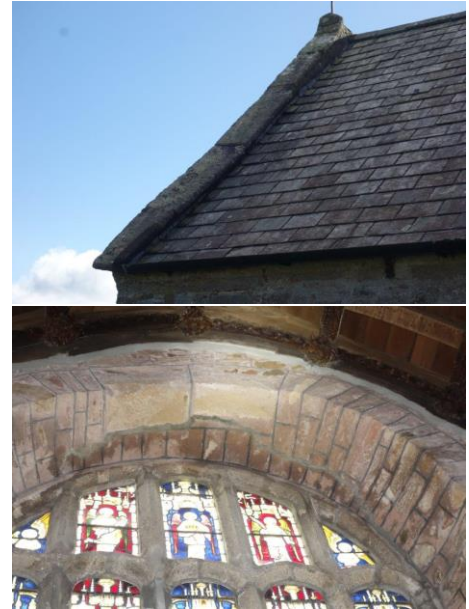
- **Component:** North aisle roof eastern parapet.
- **Description:** Parapet coping stones bedded on mortar.
- **Condition:** The coping stones were well weathered and where the mortar joints had begun to break down and wash out, moss growth had taken hold. Historic cement mortar repairs were beginning to fail. There appeared to be water migrating down in to the internal window soffit from the wall and parapet above.
- **Repair Needed:** The parapet coping stones require repointing with lime mortar and the old mortar repairs replaced with lime based equivalent. Some of the coping stones may be found to require replacement.

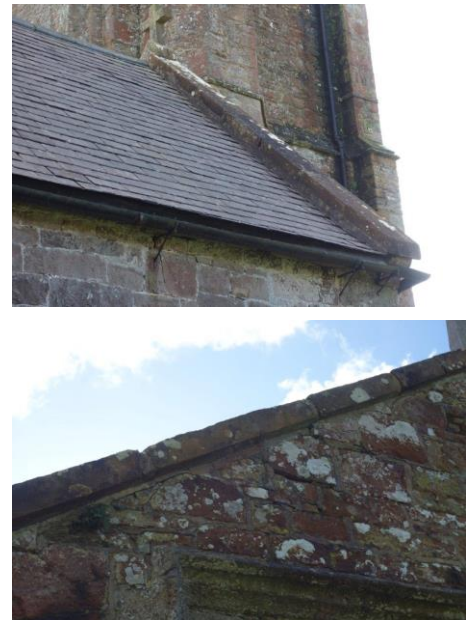
- **Component:** North aisle roof western parapet.
- **Description:** Parapet coping stones bedded on mortar.
- **Condition:** The coping stones remained largely sound. Corner of one coping stone damaged and some mortar missing. Cement flashing appeared to remain largely intact. There appeared to be water migrating down in to the internal window soffit from the wall and parapet above.
- **Repair Needed:** Localised 'stopping in' of missing mortar from between coping stones recommended.

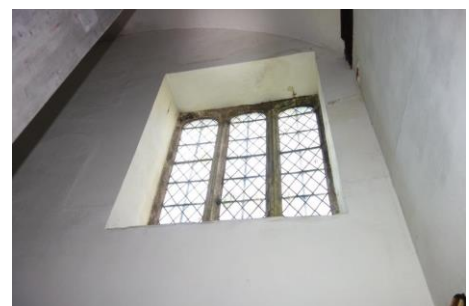
- **Component:** North transept roof parapet.
- **Description:** Parapet coping stones bedded on mortar.
- **Condition:** Mortar from in-between coping stones had washed out leaving open joints. Evidence of water ingress internally below parapet.
- **Repair Needed:** Repoint parapet coping stones.

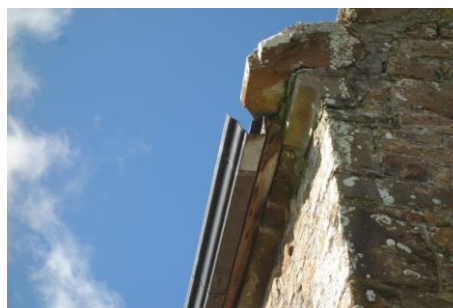
- **Component:** South aisle gutter.
- **Description:** Cast iron ogee gutter section.
- **Condition:** Missing end cap.
- **Repair Needed:** Replace missing end cap.

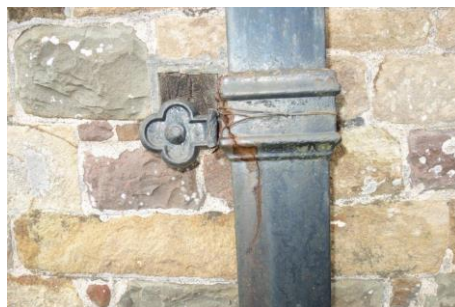
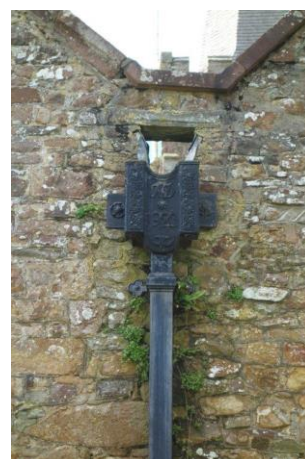
- **Component:** Cast iron hoppers and downpipes serving south aisle / nave valley and nave / north aisle valley.
- **Description:** Cast iron hoppers dated 1923 discharging into square section down pipes secured to walls with decorated strap brackets.
- **Condition:** Left hand hopper and downpipe leaking. Plants growing in masonry joints where hopper leaking. Both downpipe strap brackets loose and damaged and some held in place with wire. Paintwork wearing thin and corrosion beginning show.
- **Repair Needed:** Both hoppers and downpipes require a comprehensive refurbishment, preferably removed from site, stripped down to bare metal, repaired, treated with zinc-based primer prior to repainting. The damaged decorative strap brackets must also be salvaged, repaired and reattached.

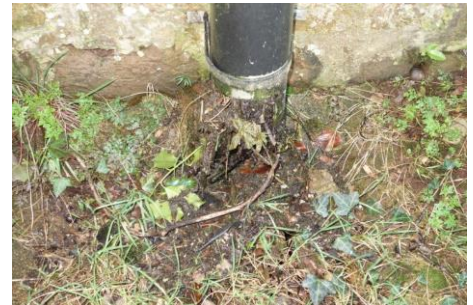
- **Component:** North aisle down pipe, adjacent tower.
- **Description:** Cast iron hopper, Upvc down pipe serving north aisle valley.
- **Condition:** Down pipe blocked with debris.
- **Repair Needed:** Unblock downpipe.

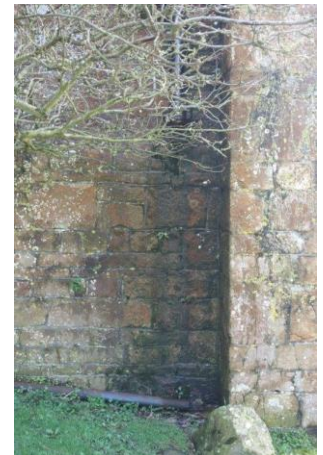
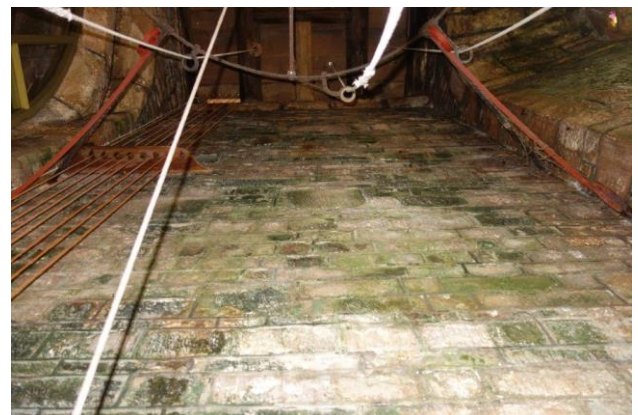
- **Component:** Tower roof downpipe.
- **Description:** Painted cast iron hopper and circular downpipe section secured to masonry with strap brackets.
- **Condition:** Leaking at all the joints and lower section detached. Contributing to significant damaging water ingress and algae growth affecting the internal walls of the tower in this location.
- **Repair Needed:** Comprehensive refurbishment required, preferably removed from site, stripped down to bare metal, repaired and treated with zinc-based primer prior to repainting.

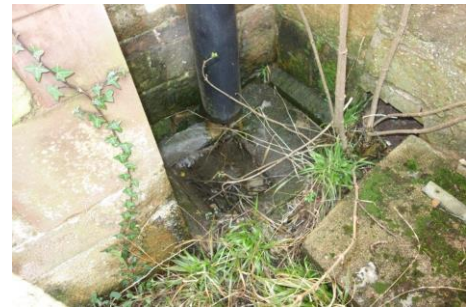
- **Component:** Gully west end of south aisle valley.
- **Description:** Yard gully.
- **Condition:** blocked with debris.
- **Repair Needed:** Ensure that this yard gully is regularly checked and debris build-up removed.

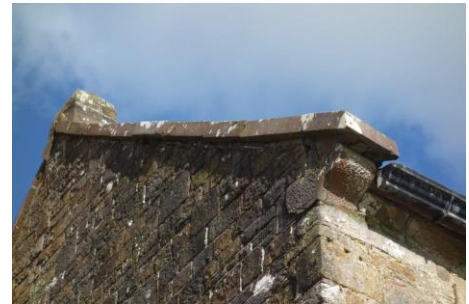
- **Component:** South aisle, west gable wall.
- **Description:** Roughly coursed stone.
- **Condition:** Cement pointing below parapet coping stones in weathered with open joints, particularly on the exposed southwest corner. Fractured and dislodged to corbel stone supporting coping stone. Internal water ingress above Window No1 appeared to be less severe than before, perhaps a result of fewer westerly gales over the winter.
- **Repair Needed:** Rake out cement mortar joints and repoint with a lime putty mortar. Reattached fractured face of corbel stone.

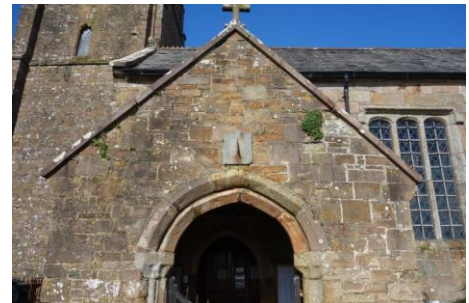
- **Component:** Porch walls.
- **Description:** Roughly coursed stone.
- **Condition:** Some areas of pointing washed out. Plant growth taking hold due to water ingress through open joints between coping stones above. Face of stonework beginning to degrade where persistently damp.
- **Repair Needed:** Localised 'stopping in' of washed out and missing mortar once the coping stones have been re-bedded and repointed.

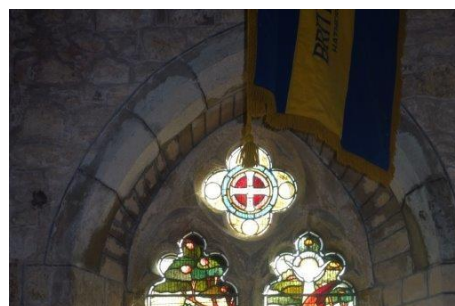
- **Component:** South aisle, south wall.
- **Description:** Roughly squared and coursed stone. Masonry appears to be bedded on lime mortar; patch repaired in cement.
- **Condition:** Some open and washed-out joints. Plant growth within bed joints below window No.2. Damp ingress affecting internal soffits of windows on this elevation appeared to be less severe than before, perhaps a result of a less stormy winter. Water ingress continued to affect the internal soffit of Window No.4 and the sill of Window No.2.
- **Repair Needed:** Localised 'stopping-in' of washed out, missing and loose mortar recommended. A lead dressing above window No.4 hoodmould might be considered as a means to prevent water ingress in this location.

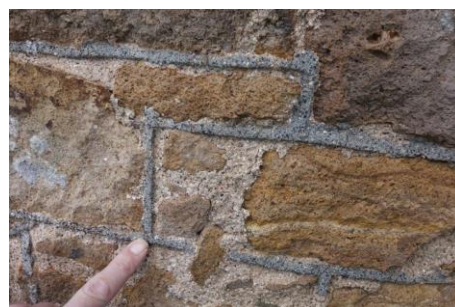
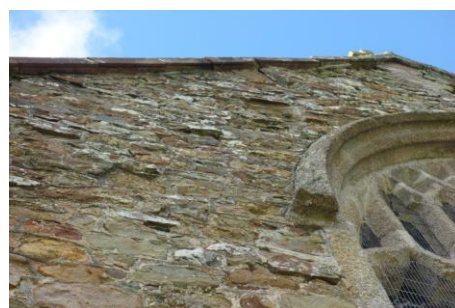
- **Component:** South aisle, nave, north aisle, east gables.
- **Description:** Roughly coursed rubble stone. Roughly squared and coursed stone. Masonry appears to be bedded on lime mortar. The exposed joints had a thin line of grey cement mortar applied on top to create a ribbon effect.
- **Condition:** The lime mortar generally remained reasonable, other than below the parapet coping stones where large areas of mortar had washed out. Elsewhere small areas of damaged, missing stone and mortar. Water ingress affecting all three internal window soffits.

Repair Needed: Localised 'stopping-in' of washed out, missing and loose mortar recommended – largely confined to area between parapet coping stones and window hoodmould. Lead dressings above the window hoodmoulds might be considered as means to prevent water ingress in this location. This work should form part a a package of works which also address the parapet coping stones above.

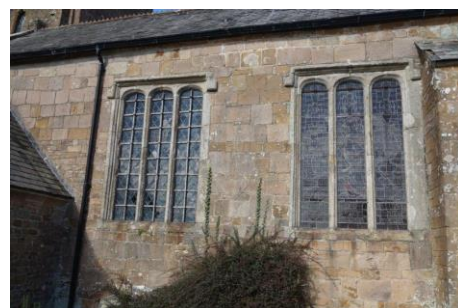
- **Component:** South aisle south Window No.2.
- **Description:** 3-light 16th Century perpendicular granite mullion window with hood mould and diamond leaded lights and external iron strap ferramenta.
- **Condition:** Stonework and ferramenta in reasonable condition. Small area of spalling to stonework on inside right-hand side jamb.
- **Repair Needed:** Mortar repair to damaged RHS stone jamb.

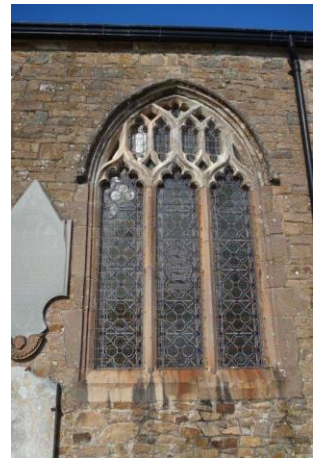
- **Component:** South aisle Window No.4.
- **Description:** Perpendicular restored 15th Century or 19th Century replacement 3-light window with hood mould. Internal glazing rods supporting leaded stained glass. External wire mesh fixed to jambs and mullions.
- **Condition:** Tracery remained in good condition. Some surface corrosion to glazing rods. External wire mesh causing staining to stone mullions and sill.
- **Repair Needed:** Removal of all mesh and corroding fixings from all windows should be considered.

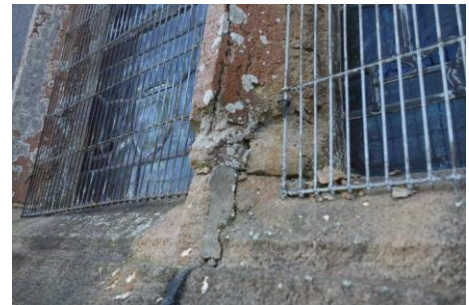
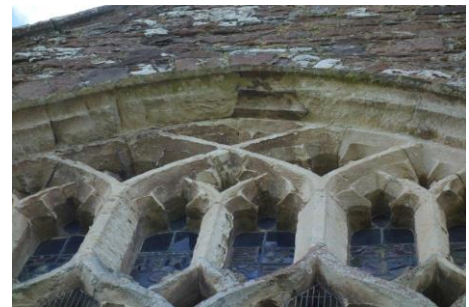
- **Component:** South aisle West Window No.6.
- **Description:** 19th Century decorated style 4-light window with hood mould. Internal glazing rods supporting leaded stained glass. External wire mesh.
- **Condition:** Other than water staining, tracery in reasonable condition internally. Some surface corrosion to glazing rods. Damage to external central mullion. External tracery suffering from surface blistering and weathering below drip mould. Mesh fixings corroding.
- **Repair Needed:** Stone indent repair required to lower central mullion.

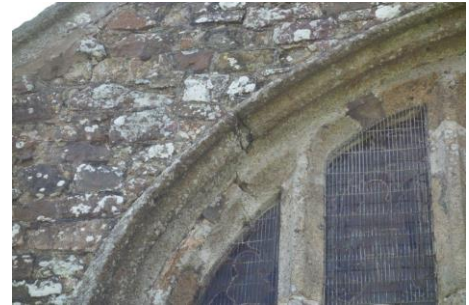
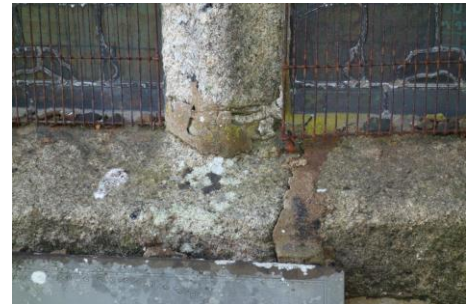
-
- **Component:** North aisle West Window No.8.
- **Description:** 16th Century or 17th Century plain 4-light window with hood mould. Internal glazing rods supporting leaded stained glass. External wire mesh.
- **Condition:** Fracture to right-hand-side hoodmould; crack continued through tracery below. Some opening of mortar joints and moss growth present. Cement repairs failing around joints. Some surface corrosion to glazing rods. Mesh fixings corroding.
- **Repair Needed:** Replace cement repairs with lime mortar repairs and fill cracks and open joints with lime mortar.

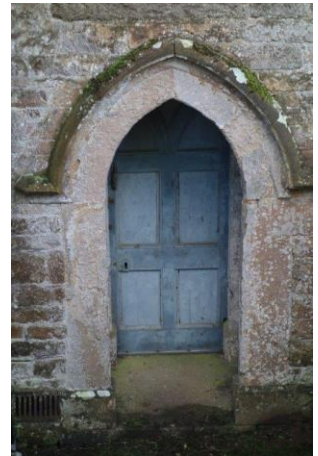
- **Component:** North transept (Vestry) Door No.3.
- **Description:** Plain 2-centered stone arch fitted with timber panel doors.
- **Condition:** Stone quoins well weathered. Door in need of redecoration.
- **Repair Needed:** Redecorate door.

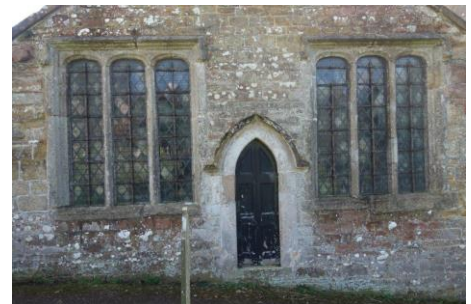
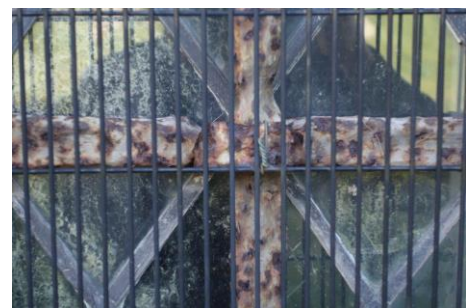
- **Component:** North transept north Window No.10.
- **Description:** 16th Century granite perpendicular 3-light window with external iron trap ferramenta, diamond leaded lights and external wire mesh.
- **Condition:** Iron strap ferramenta suffering from corrosion. One mortar joint around the granite stone sections.
- **Repair Needed:** Fill in missing and washed-out mortar joints with lime mortar.
- **Repair Needed:** Iron strap ferramenta in need of comprehensive overhaul.

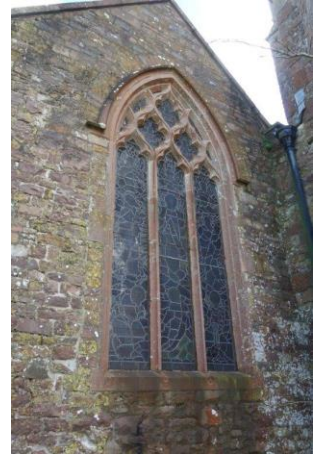
- **Component:** North aisle west Window No.14.
- **Description:** Perpendicular 19th Century 3-light window Internal glazing rods supporting leaded stained glass. External wire mesh.
- **Condition:** Tracery in reasonable condition. Some wind driven rain water seeping through gaps in the leadwork. Fracture to right-hand-side jamb filled with cement or filler.
- **Repair Needed:** Stained glass lead comes require refurbishment.

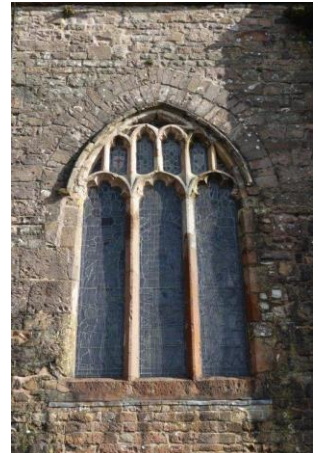
- **Component:** Tower west Window 15.
- **Description:** Perpendicular restored or 19th Century 3-light window Internal glazing rods supporting leaded stained glass. External wire mesh.
- **Condition:** Internal face of tracery reasonable, despite running water ingress above and around window reveal. External tracery weathered within open joints around hood mould.
- **Repair Needed:** Fill in missing and washed-out mortar joints with lime mortar.

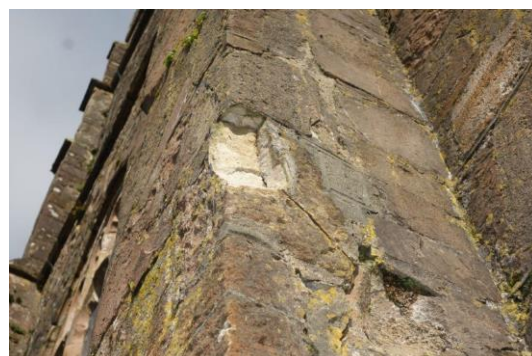
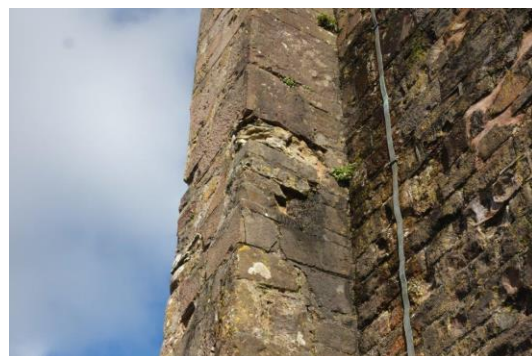
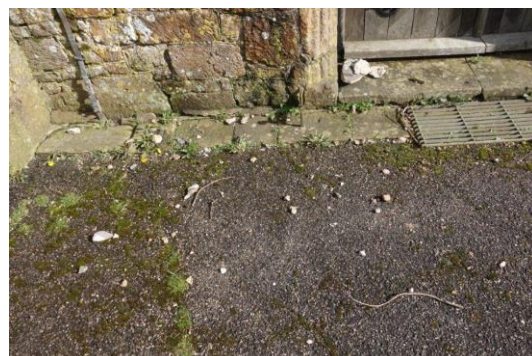
- **Component:** Tower external walls.
- **Description:** Roughly coursed local sandstone with dressed stone quoins.
- **Condition:** Face of stones weathered and delaminating; a generous distribution of delaminated stone and mortar surrounded the base of the tower at the time of the inspection, revealing an increasing health and safety risk.

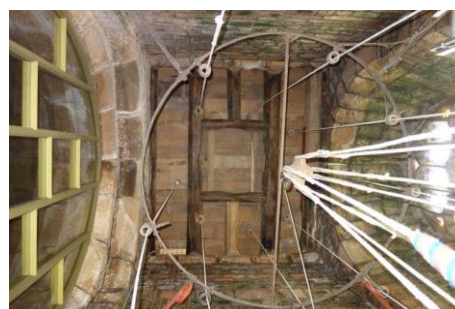
- **Component:** Tower – 1st level, deadening chamber floor.
- **Description:** Large chamfered oak floor beams supporting oak floorboards.
- **Condition:** Floor structure and boards recently repaired. Beam ends scarf jointed and steel plated. At risk of decay caused by continuing damp ingress.
- **Repair Needed:** At risk of decay caused by continuing damp ingress.

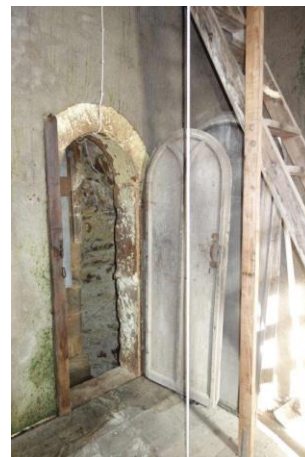
- **Component:** Tower internal walls – 1st level, deadening chamber walls.
- **Description:** All exposed stonework rendered with hard, grey cement render.
- **Condition:** Render wet and suffering algae growth.
- **Repair Needed:** Render requires removal to aid drying out of wall. Repointing recommended thereafter in coordination with a programme of works which encompasses the external walls.

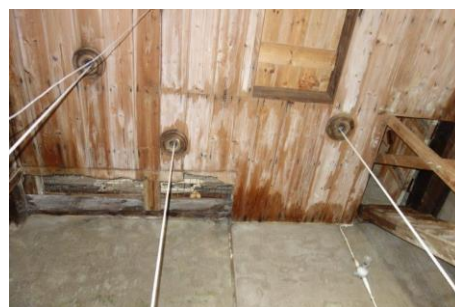
- **Component:** Tower - 2nd level, clock chamber floor.
- **Description:** **timber** Softwood floor joists and boards. Underside ceiling boarded out with softwood tongue and groove boards.
- **Condition:** Timber joists and boards suffering wet rot decay and wood boring beetle damage, caused by transference of moisture from wet walls.
- **Repair Needed:** Timbers floorboards require lifting and condition of joists inspecting. Further repairs may be required.

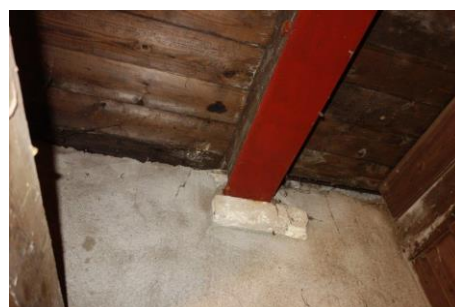
- **Component:** Tower – 3rd level, bell chamber floor.
- **Description:** Floor beams concealed behind softwood boarded ceiling. Steel beam recently repainted providing additional structural support to weight of bells above.
- **Condition:** Water ingress continues internally to cause corrosion to the steel beam and wet rot decay to the timber floor structure.
- **Repair Needed:** Water ingress must be addressed in order to halt the continuing damage occurring to the timber and steel floor structure, otherwise recent repairs will soon begin to fail again.

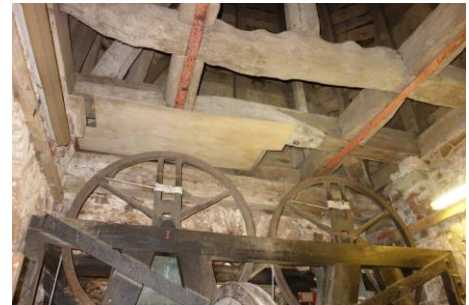
- **Component:** Tower internal walls – 3rd level, bell chamber walls.
- **Description:** Roughly coursed local sandstone with dressed stone quoins.
- **Condition:** Water ingress apparent, yet remains relatively dry due to through draft created by the belfry windows.
- **Repair Needed:** Repointing recommended in coordination with a programme of works which encompasses the external walls.

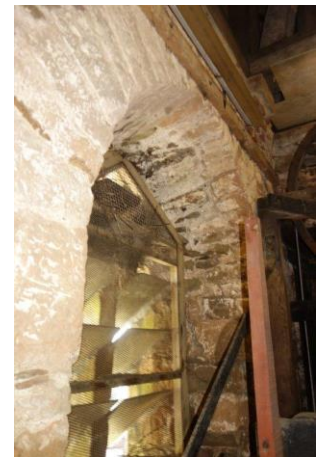
- **Component:** Tower– 3rd level, belfry windows
- **Description:** Open 2-centered, 2-light windows, one to each elevation, fitted with slate louvres and anti-bird wire mesh fixed to rear face.
- **Condition:** Some delamination to tracery. Condition and stability of slate louvres hard to determine, due to the unsafe and difficult access offered within the bell chamber. Some slates appeared to have moved and may have worked loose.
- **Repair Needed:** Slate louvres require checking by a rope access team to ensure they are secure.
