Quinquennial Inspection of Hatherleigh's St John the Baptist's Church

Diocese: Exeter
Archdeaconry: Totnes
Deanery: Okehampton
Church: St John the Baptist
Parish: Hatherleigh

Date of Inspection: 22 February 2021
Inspector: Sam Percival
Company: Building Conservation Services
Address: Canns Down, Beaford Devon, EX19 8AD

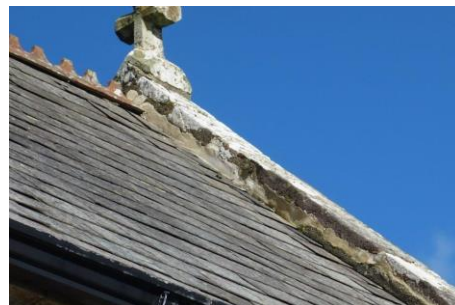
6.10

- **Component:** South aisle eastern parapet.
- **Description:** Cement flashing over slate to rear face of parapet.
- **Condition:** Cement flashing cracked and falling away in places. Repaired in places with mortar.
- **Repair Needed:** Replacement of cement flashing with lead soakers and flashings should be undertaken when slate roof re-laying undertaken.

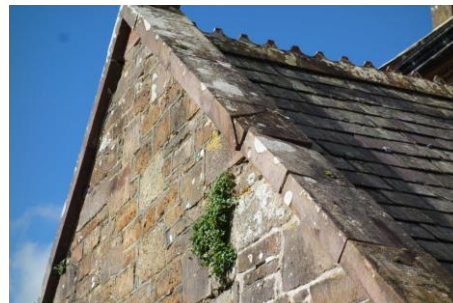
6.15

- **Component:** Porch roof parapet.
- **Description:** Parapet coping stones.
- **Condition:** Mortar from in-between coping stones washed out. Fractured coping stone to eastern slope. Water ingress through coping stones saturating stonework below, resulting in plant growth to take hold within the masonry joints.
- **Repair Needed:** Re-bed and repoint coping stones and repair or renew fractured coping stone.

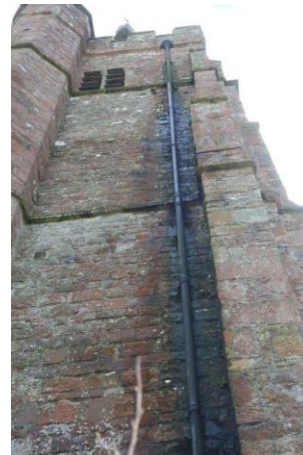
6.21

- **Component:** Tower roof downpipe.
- **Description:** Painted cast iron hopper and circular downpipe section secured to masonry with strap brackets.
- **Condition:** Leaking at all the joints and lower section detached. Contributing to significant damaging water ingress and algae growth affecting the internal walls of the tower in this location.
- **Repair Needed:** Comprehensive refurbishment required, preferably removed from site, stripped down to bare metal, repaired and treated with zinc-based primer prior to repainting.

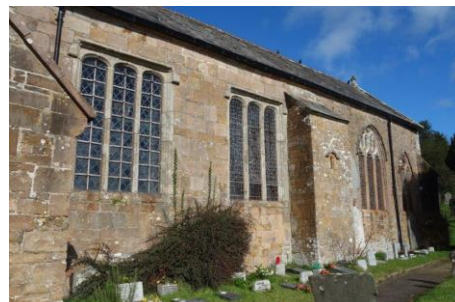
6.29

- **Component:** South aisle, south wall.
- **Description:** Roughly squared and coursed stone. Masonry appears to be bedded on lime mortar; patch repaired in cement.
- **Condition:** Some open and washed-out joints. Plant growth within bed joints below window No.2. Damp ingress affecting internal soffits of windows on this elevation appeared to be less severe than before, perhaps a result of a less stormy winter. Water ingress continued to affect the internal soffit of Window No.4 and the sill of Window No.2.
- **Repair Needed:** Localised 'stopping-in' of washed out, missing and loose mortar recommended. A lead dressing above window No.4 hoodmould might be considered as a means to prevent water ingress in this location.

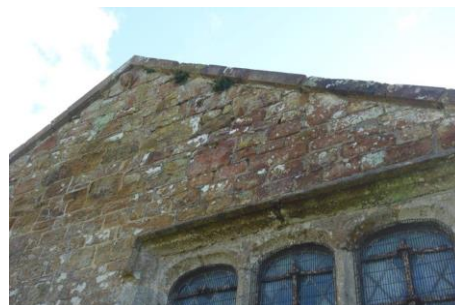
6.31

- **Component:** North aisle north wall and transept walls.
- **Description:** Roughly squared and coursed stone. Masonry appears to be bedded on lime mortar; patch repaired in cement.
- **Condition:** The mortar generally remained reasonable, other than below the transept parapet coping stones where large areas of mortar had washed out and plant growth had taken hold. Face of stonework beginning to degrade where persistently damp.
- **Repair Needed:** Localised 'stopping in' of washed out and missing mortar once the coping stones have been repointed.

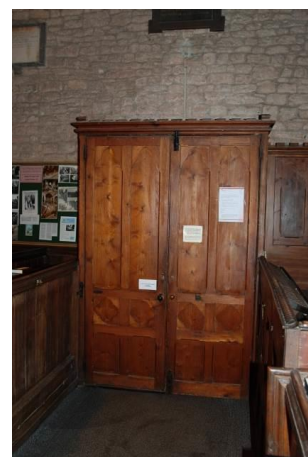
6.35

- **Component:** Main entrance lobby - Door No.1.
- **Description:** 19th Century oak panelled inner lobby fitted with double doors executed in the perpendicular style.
- **Condition:** Joinery work appeared sound a free of significant wood boring beetle damage.
- **Repair Needed:** No action required at present time.

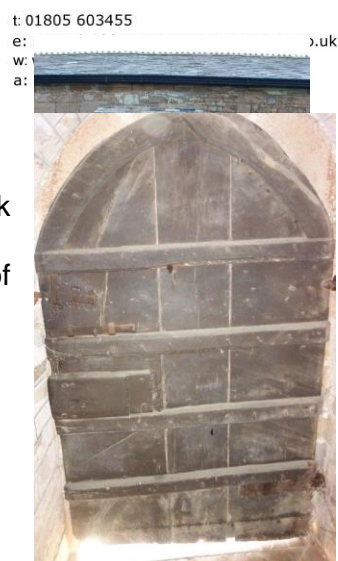
6.36

- **Component:** Main entrance - Door No.2.
- **Description:** 2-centered gothic stone arch. Early studded oak panel door fitted with original wooden lock and iron strap hinges.
- **Condition:** Stonework sound. Oak door remained dry and free of significant defect.
- **Repair Needed:** No action required at present time.

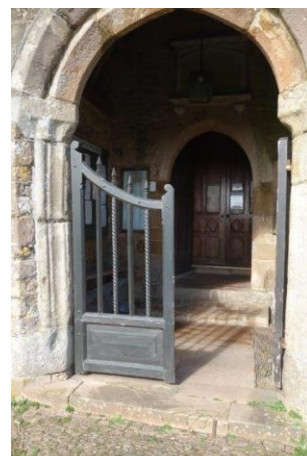
6.37

- **Component:** Porch gates.
- **Description:** Oak framed gates with raised and fielded lower panels and barley twist pikes.
- **Condition:** Remained in good order.
- **Repair Needed:** No action required at present time.

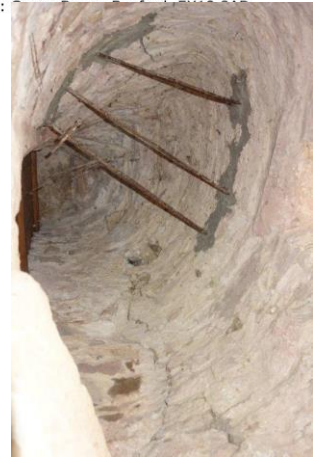
6.40

- **Component:** South aisle Door No.3.
- **Description:** Blocked priest's door with dressed ashlar quoins and door opening to spiral stone staircase leading to upper door opening formally providing access to upper level of rood screen removed on the order of Henry VIII.
- **Condition:** Cracking to internal walls and corroding ties bars at high level. Wall appeared to have stabilised.
- **Repair Needed:** No action required at present time.

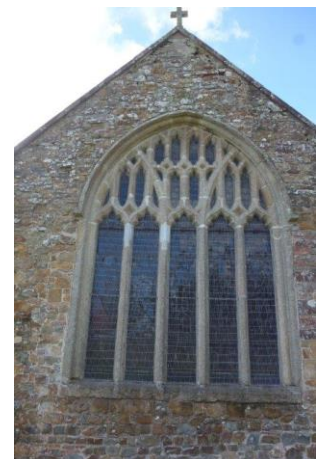
6.44

- **Component:** Nave West Window No.7.
- **Description:** 16th Century decorated style 5-light granite window with hood mould. Internal glazing rods supporting leaded stained glass. External wire mesh.
- **Condition:** Tracery in reasonable condition. Some surface corrosion to glazing rods. Mesh fixings corroding.
- **Repair Needed:** No action required at present time.

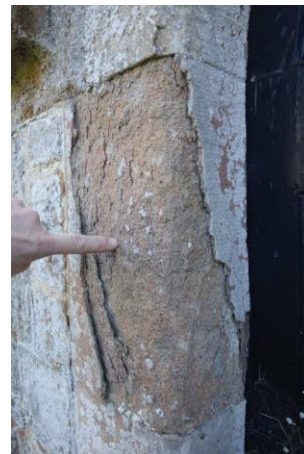
Component: North transept north Door No.4.

- **Description:** Plain 2-centered arch with hood mould and double opening panel door – blocked from the inside.
- **Condition:** Surface to stone quoins delaminating to both sides of door – this had become progressively worse since the last inspection Hood mould suffering damp ingress and moss growth.
- Door in need of redecoration.
- **Repair Needed:** Stabilise delaminated stone apply lime shelter coat.
- **Repair Needed:** Redecorate door.

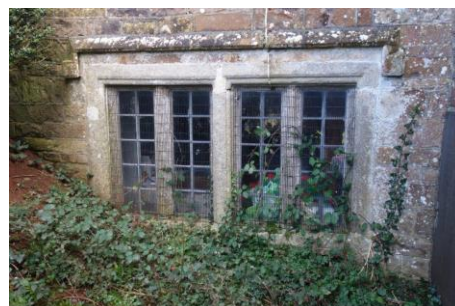
6.51

- **Component:** North transept west Window No.12.
- **Description:** 16th Century granite 4-light mullion window, vertical iron glazing bar dividing each opening, supporting rectangular glass panes set in lead cames.
- **Condition:** External ground level above window cill allowing internal water ingress. Internal mullions and cill wet and green with algae. Iron glazing bars corroding. Left hand side glazing bar corroded and expanded causing granite cill to shear off.
- **Repair Needed:** Lower external ground level below internal window cill. Refurbish iron glazing bars and reset fractured stone cill.

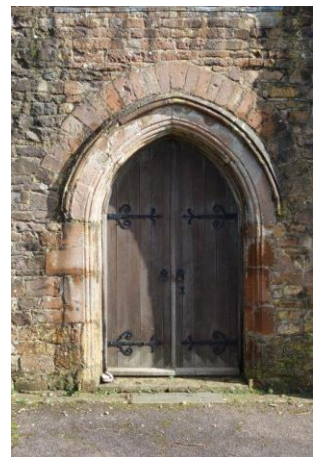
6.56

- **Component:** Tower east Door No.6.
- **Description:** 2-centered rib moulded arch and quoins, hood mould and a 19th Century plank door with decorated strap hinges.
- **Condition:** Hood mould damaged and weathered, otherwise sound.
- **Repair Needed:** No action required at present time.

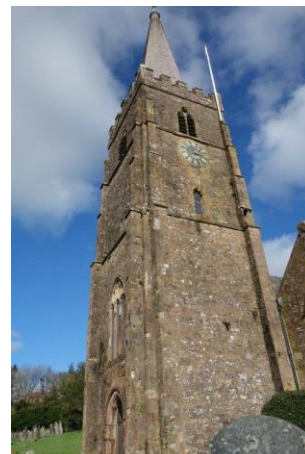
- I. Leaking tower down pipe;
- II. Exposed tower stage string course;
- III. Unstable and damaged merlon coping stones;
- IV. Defective pointing and falling masonry.

6.60 Although it is an overwhelming and expensive problem to take on, the issue of water ingress and defective masonry affecting the tower has to be addressed as soon as possible, not least because the amount of masonry falling from the tower is becoming an increasing health and safety hazard, but also because the longer the problem remains unresolved the worse the damage caused will become and the more expensive it will ultimately become to resolve.

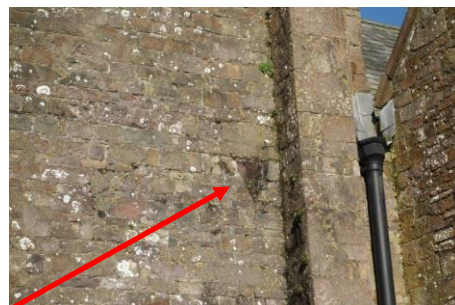
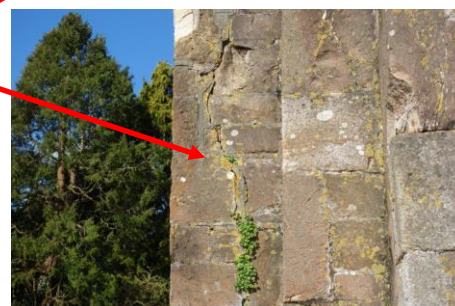
- **Component:** Tower external walls.
- **Description:** Roughly coursed local sandstone with dressed stone quoins.
- **Condition:** Face of stones weathered and delaminating; a generous distribution of delaminated stone and mortar surrounded the base of the tower at the time of the inspection, revealing an increasing health and safety risk.

- Water collecting within the wall core and leaching out of the walls at lower levels.
- Crack running vertically up the southwest buttress.
- Plants taking hold in the damp and open mortar joints on all sides.

- **Repair Needed:** A comprehensive programme of refurbishment is required, to include:
 - I. the removal of plant growth;
 - II. repointing works;
 - III. tying-in of southwest buttress stonework;

- IV. removal of friable and dangerous stonework;
 - V. possible grout filling of wall core voids;
 - VI. dressing of exposed string courses with lead.

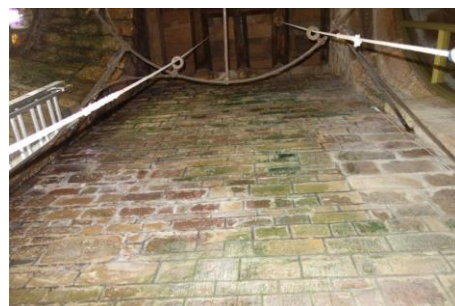
6.61

- **Component:** Tower internal walls – Ground level, ringing chamber walls.
- **Description:** Roughly coursed local stone with dressed stone quoins.
- **Condition:** Walls very wet, water dripping from the west window reveal. Hard cement ribbon pointing throughout.
- **Repair Needed:** Repointing recommended in coordination with a programme of works which encompasses the external walls.

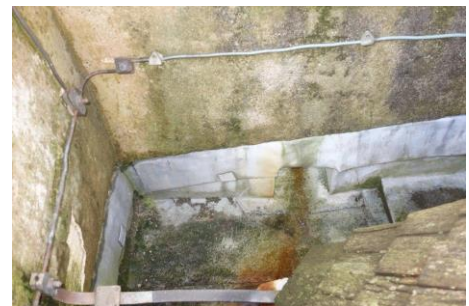
6.69

- **Component:** Tower roof covering
- **Description:** Lead valley gutter and flashings between timber spire and stone crenellations.
- **Condition:** Lead remains reasonable.
- **Repair Needed:** No action required at present time.

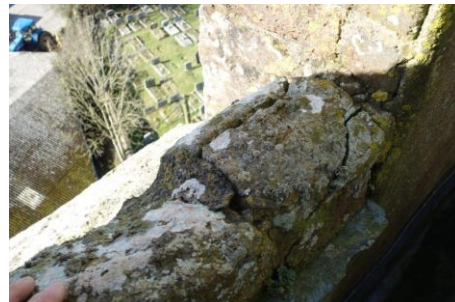
6.70

- **Component:** Tower parapet
- **Description:** Masonry crenelated parapet.
- **Condition:** Mortar joints between merlins washed out now require repointing. 3no. fractured and crumbling coping stones to west side. Loose cement repair to coping stone on south side. Crumbling stonework poses increasing risk of injury.
- **Repair Needed:** Repointing required to all sides and consolidation or replacement of crumbling coping stones and cement repairs required.

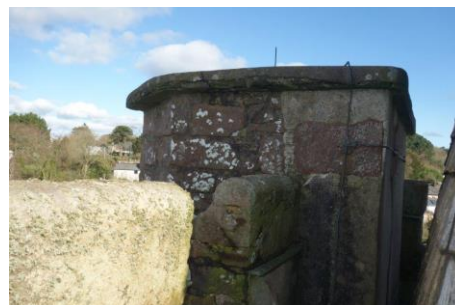
6.71

- **Component:** Stair turret door and roof.
- **Description:** Part cement rendered stone walling with a reinforced concrete slab type roof.
- **Condition:** Render loose and concrete slab cracking.
- **Repair Needed:** Cement render requires removal and stones repointed. Concrete slab roof requires repairing or replacing

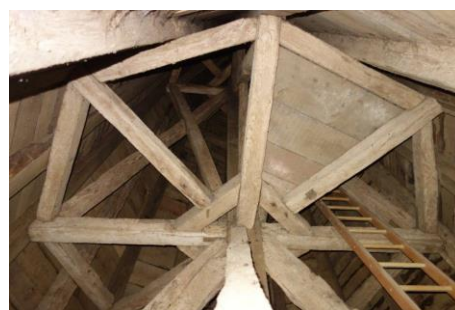
6.73

- **Component:** Tower - Spire
- **Description:** Timber-framed spire clad with cedar shingle over boards. Rebuilt in 1991 following disastrous storm which blew the spire in to the nave roof.
- **Condition:** Tower frame in good condition. Some common furniture beetle (*Anobium Punctatum*) damage to a few of the lining boards – this due to the use of the softer sapwood for some of the boards. Cedar shingles continuing to perform well.
- **Repair Needed:** No action required at present time.

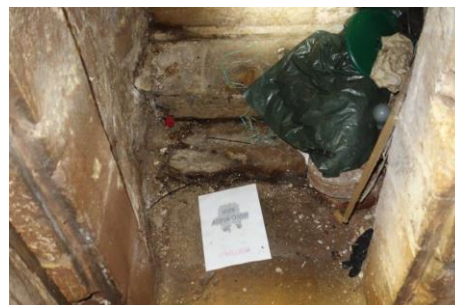
6.74

- **Component:** Turret stair
- **Description:** Fair faced stone walls, timber treads to deadening chamber and stone treads thereafter. Lighting throughout.
- **Condition:** As with the rest of the tower the turret walls were damp. The timber treads were rotting in the damp environment. Particularly uneven and unstable at the base of the tower and at the half landing adjacent to the bell chamber. Condition of wooden stair structure noticeably worse since previous inspection.
- **Repair Needed:** The timber stair treads and underlying supporting timber structure require extensive repairs, preferably following the remedy of the water ingress affecting the tower.

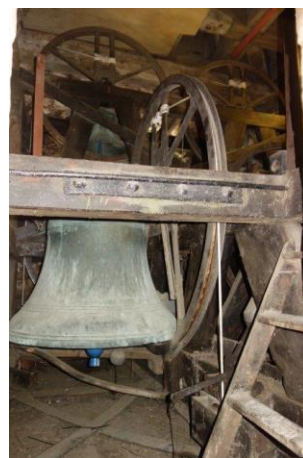
6.75

- **Component:** Bells and bell-frame
- **Description:** 8no. bells within dark stained timber bell-frame braced with iron strap work and built into walls.
- **Condition:** Appeared to be reasonable.
- **Repair Needed:** No action required at present time.

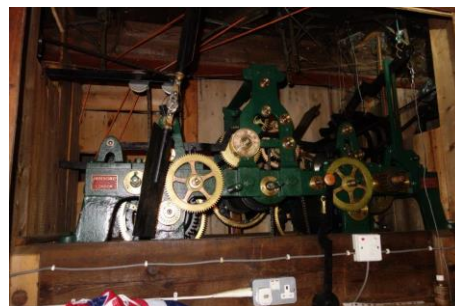
6.76

- **Component:** Clock
- **Description:** Clock face dated 1929. Mechanism housed within timber framed cupboard. Converted to electric mechanism. Weights now removed.
- **Condition:** Appeared to be working and well maintained.
- **Repair Needed:** No action required at present time.

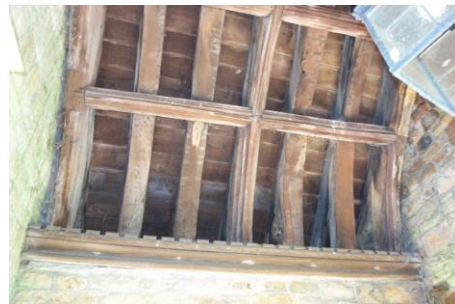
6.77

- **Component:** Porch
- **Description:** Double arch braced roof with moulded ribs. Original lath and plaster infill removed. Central decorated rose supporting chain and with leaded lantern.
- **Condition:** Water ingress below south facing parapet causing wet rot decay to adjacent roof timbers. Some common furniture beetle (*Anobium Punctatum*) damage to damp areas noted.
- **Repair Needed:** Repairs to parapet flashing repairs and repointing of parapet coping stones required as recommended above.

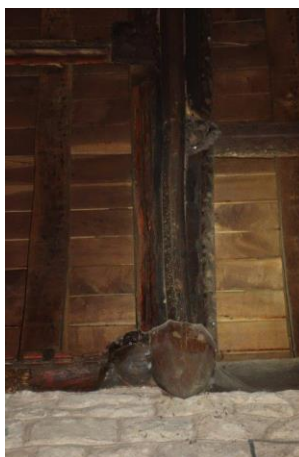
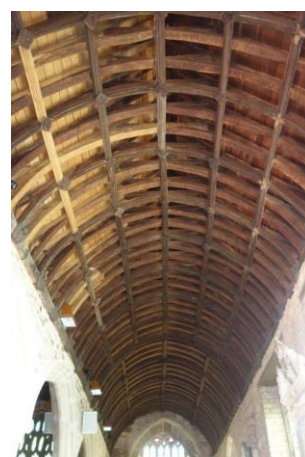
6.78

- **Component:** South aisle roof.
- **Description:** Double arch braced roof, longitudinal moulded ribs with carved timber bosses at junction of principle rafters. Gold and red paint to ribs and bosses over east end of southern aisle (formally a chapel). Lath and plaster infill removed.
- **Condition:** Timbers abutting damp walls at risk of wet rot decay.
- Death watch beetle damage to trusses above rood stair.
- **Repair Needed:** Closer inspection of timbers trusses affected by wood boring beetle damage recommended to assess whether infestation of death watch beetle remains active.

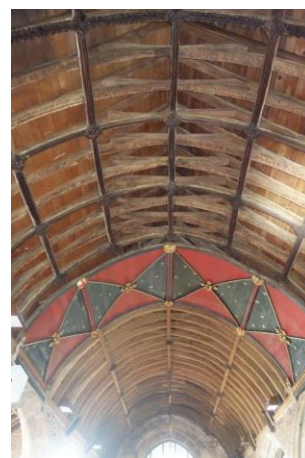
6.79

- **Component:** Nave roof.
- **Description:** Double arch braced roof, with longitudinal ribs and carved timber bosses at intersection of ribs with every 6th rafter. Lathe and plaster infill removed.
- **Condition:** Roof structure comprehensively repaired following 1990 storm damage. Remains in good condition, albeit at risk of water ingress damage due to the number of slipped and missing slates above.
- **Repair Needed:** No action required at present time.

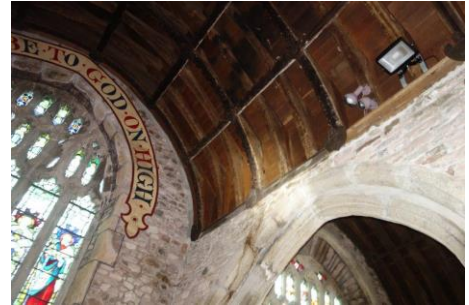
6.80

- **Component:** Chancel roof.
- **Description:** Double arch braced roof. Moulded rib to purlins and every 4th rafter and craved bosses at intersection of moulded ribs. Lathe and plaster infill removed. Single bay of roof boarded, painted and gilded at junction of nave and chancel.
- **Condition:** Generally good. Some historic water ingress staining. Timbers abutting damp walls at risk of wet rot decay.
- **Repair Needed:** No action required at present time, other than repointing works to external walls to abate water ingress.

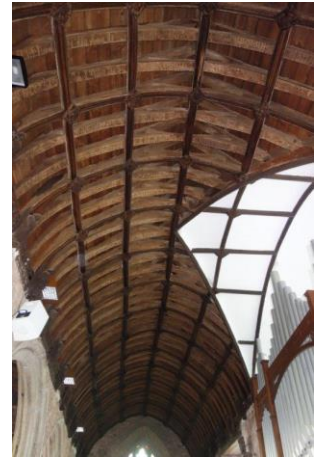
6.81

- **Component:** North aisle roof.
- **Description:** Double arch braced roof. Moulded rib to purlins and every 4th rafter and craved bosses at intersection of moulded ribs. Truss feet supported by decorated corbels. Carved timber angels at junction of rafters and carved wall plate. Lathe and plaster infill removed.
- **Condition:** Generally good. Some historic water ingress staining. Timbers abutting damp walls at risk of wet rot decay.
- **Repair Needed:** No action required at present time, other than repointing works to external walls to abate water ingress.

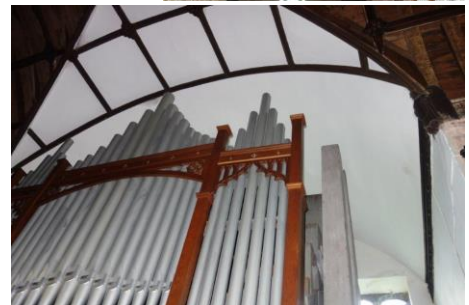
6.82

- **Component:** North transept roof.
- **Description:** Plastered barrel-vaulted roof.
- **Condition:** Some signs of movement and water ingress associated with the defective parapet coping stones above, otherwise appeared relatively sound, although nail fixings may be corroding.
- **Repair Needed:** No action required at present time.

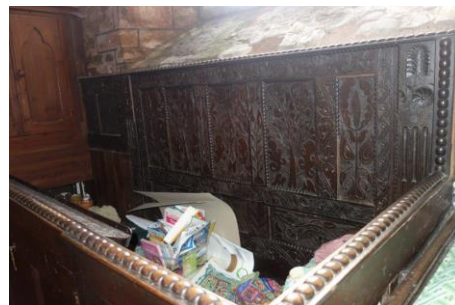
6.83

- **Component:** Box pew and panelling to west of south entrance.
- **Description:** Oak panelled pew, with renaissance carvings dated 1683.
- **Condition:** Reasonable. Section missing with electrical cupboard
- **Repair Needed:** No action required at present time.

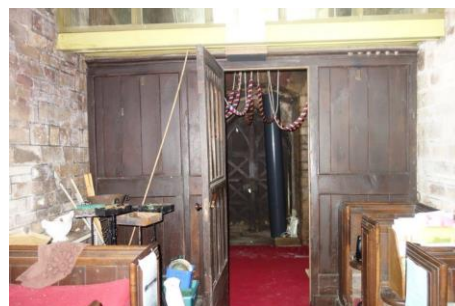
6.84

- **Component:** Tower Screen
- **Description:** 19th Century panelled oak, gothic screen with central, part glazed door.
- **Condition:** Reasonable.
- **Repair Needed:** No action required at present time.

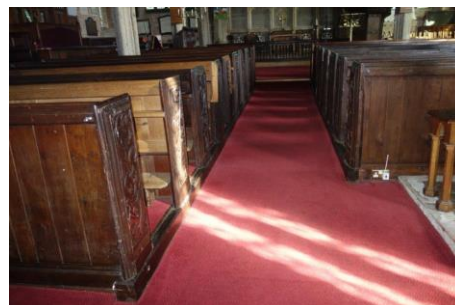
6.85

- **Component:** Nave, aisles & north transept floors.
- **Description:** Laid to carpet. Uneven hard floor beneath, likely to be stone slabs or tiles.
- **Condition:** Appeared sound.
- **Repair Needed:** No action required at present time.

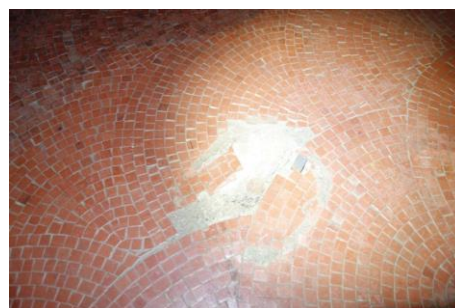
6.87

- **Component:** Chancel floor.
- **Description:** 19th Century mosaic edged with oak boards at two levels with a step up to communion table.
- **Condition:** Some missing and damaged tiles to south west corner of flooring. Damp noted rising to northern edge of lower mosaic floor.
- **Repair Needed:** Repair to mosaic preferable.

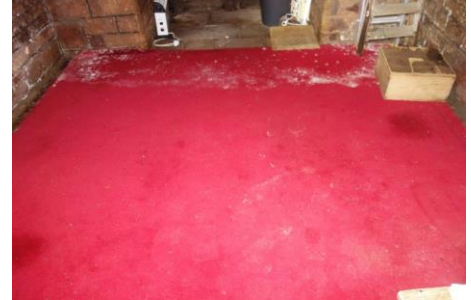
6.88

- **Component:** Tower floor.
- **Description:** Stone paviments to west door entrance. Carpeted elsewhere.
- **Condition:** Carpet very mouldy on account of the amount of water running down the tower. Where exposed stone paviments appeared to remain sound.
- **Repair Needed:** Removal of carpet recommended.

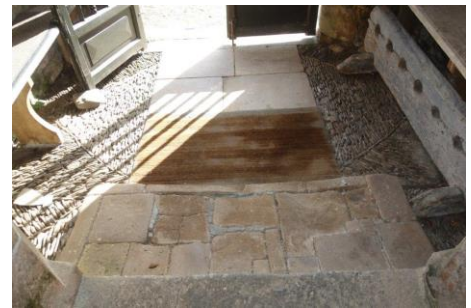
6.89

- **Component:** Porch floor.
- **Description:** Stone paviments and cobbles. Diamond laid terracotta tiles within lobby entrance.
- **Condition:** All well worn but appeared sound.
- **Repair Needed:** No action required at present time.

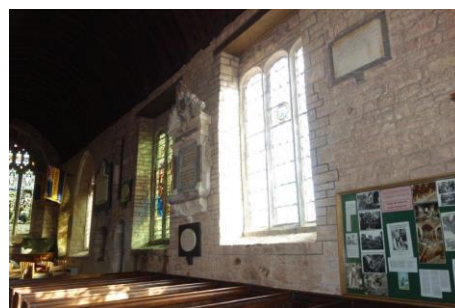
6.91

- **Component:** South aisle walls.
- **Description:** Exposed roughly coursed rubble masonry with shaped quoins to openings. 5-bay granite arcades separating the nave from the south aisle.
- **Condition:** Largely dry, with the exception of the western gable wall and above the window openings. Arcade remains sound. Repaired after 1990 storm damage.
- **Repair Needed:** Refer to recommendations under Window and Doors section above.

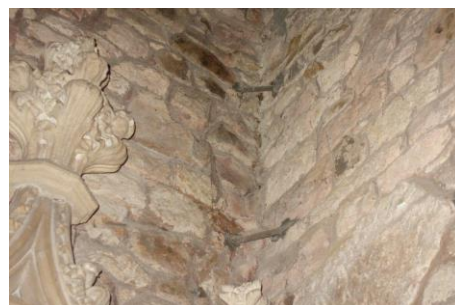
6.92

- **Component:** Chancel east wall.
- **Description:** Exposed roughly coursed rubble masonry with shaped quoins to openings.
- **Condition:** Very old glass tell-tales attached at junction of gable wall and south arcade. Reassuringly, the glass tell-tales remained intact, evidence that the wall remains stable.
- **Repair Needed:** No further action required at this time.

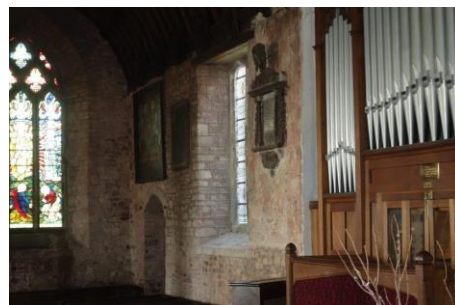
6.93

- **Component:** North aisle walls.
- **Description:** Exposed roughly coursed rubble masonry with roughly shaped quoins to openings. 5-bay granite arcades separating the nave from the north aisle.
- **Condition:** Largely dry, with the exception of the western gable wall and above the window openings. Arcade remains sound.
- **Repair Needed:** Refer to recommendations under Window and Doors section above.

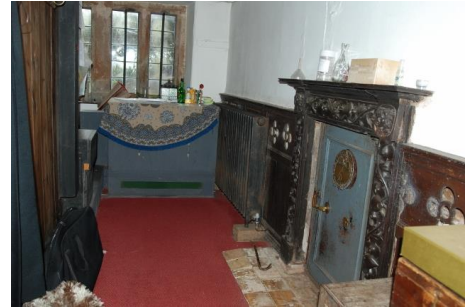
6.95

- **Component:** North transept walls.
- **Description:** Plastered masonry wall. Lower section consisted of stud work lining with lath and plaster finish above timber panelling.
- **Condition:** The ground level to the transept north wall is some 2 metres above the internal floor level. The walls are remarkably dry despite this. The studwork and system of vent holes in the timber panelling appear to be allowing some drying out of the wall. Behind the panelling was visible salt build up and clearly the masonry wall was damp. Damp has caused algae growth around the west window to form.
- **Repair Needed:** Although no issues were obvious, the damp conditions of the wall will over time lead to the decay of the studwork walls and panelling. In the long-term damp ingress prevention will likely be required.

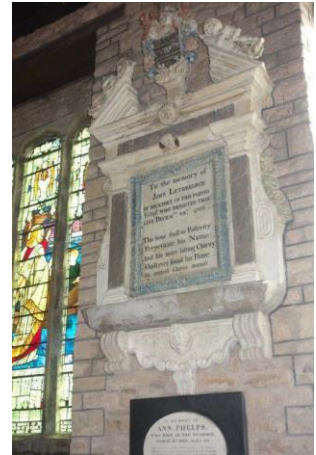
6.96

- **Component:** South aisle monuments.
- **Description:** 9no. wall mounted monuments including ornate marble neo-classical monument to John Letherbridge dated 1707.
- **Condition:** Although all appeared reasonable, the fixings are at risk of corrosion from water ingress from wall behind.
- **Repair Needed:** Signs of movement where hidden fixings prone to corrosion due to walls are damp should be reported at the earliest opportunity.

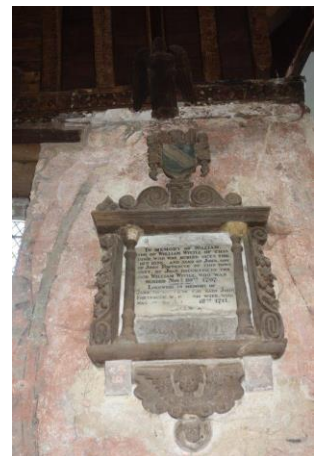
6.97

- **Component:** North aisle monuments.
- **Description:** 10no. wall mounted monuments including dark stone neo-classical monument to William Wivell dated 1706.
- **Condition:** Although all appeared reasonable, the fixings are at risk of corrosion from water ingress from wall behind.
- **Repair Needed:** Signs of movement where hidden fixings prone to corrosion due to walls are damp should be reported at the earliest opportunity.

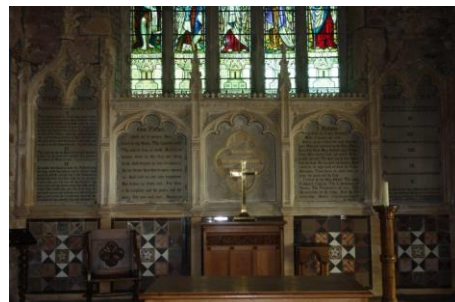
- **Component:** Chancel east wall.
- **Description:** 19th Century perpendicular limestone screen decorated within crocketed pinnacles and ogee shaped arches and infilled with verses including the Lord's Prayer. Lower section decorated with Minton style tiles.
- **Condition:** Some water staining caused by water ingress around the east window behind. Two panels of Minton tiles to north side bowing out with surface salt crystal deposits caused by the migration of damp through the monument.
- **Repair Needed:** The Minton tiles are very close to failure. Water ingress caused by the failure of the external cement pointing must first be remedied before a repair to the tiles is attempted.

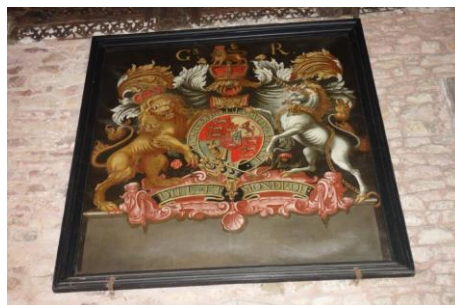
6.98

- **Component:** North aisle Coat of Arms.
- **Description:** George II or III Royal Coat of arms
- **Condition:** Appears reasonable, at risk from water ingress from wall behind.
- **Repair Needed:** No further action required at this time.

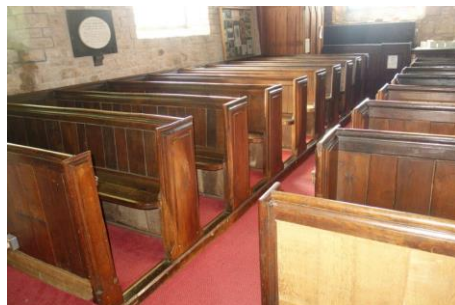
6.99

- **Component:** South aisle Pews.
- **Description:** 19th century pews to south aisle on raised timber flooring.
- **Condition:** All remain in a good serviceable condition.
- **Repair Needed:** No Action required at present time.

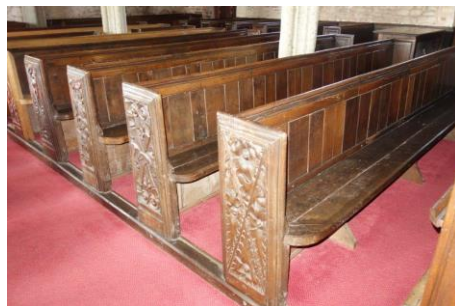
6.100

- **Component:** Nave and North aisle stalls.
- **Description:** 16th Century bench depicting perpendicular tracery and renaissance naturalistic designs.
- **Condition:** Some evidence of common furniture beetle infestation – Non presently live. All remain in a good serviceable condition.
- **Repair Needed:** No action required at present time.

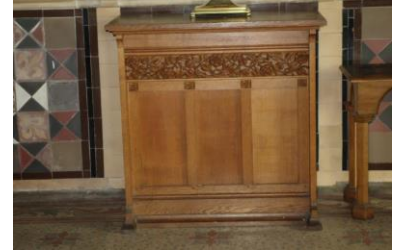
6.101

- **Component:** Alter.
- **Description:** 19th or 20th Century with decorative freeze.
- **Condition:** Remains in a good serviceable condition.
- **Repair Needed:** No action required at present time.

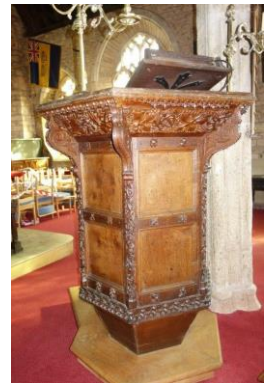
6.102

- **Component:** Pulpit.
- **Description:** 16th Century or early 17th Century ornately carved with scrolled brackets and naturalistic leaf mouldings. Recently set on to an oak plinth fitted with casters to enable it to be easily moved.
- **Condition:** Remains in good serviceable condition.
- **Repair Needed:** No action required at present time.

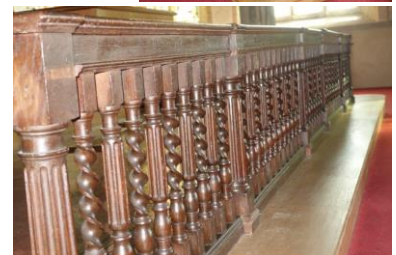
6.103

- **Component:** Alter Rail.
- **Description:** 18th Century with barley twist and fluted balusters and central gate.
- **Condition:** Some historic wood being beetle damage, otherwise, remained in good condition.
- **Repair Needed:** No action required at present time.

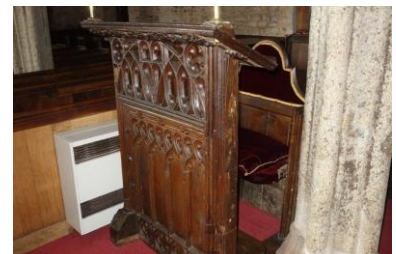
6.104

- **Component:** Oak lectern
- **Description:** Made up of sections of the 15th Century Rood Screen.
- **Condition:** Some historic wood being beetle damage, impact damage and repairs, otherwise remained in good condition.
- **Repair Needed:** No action required at present time.

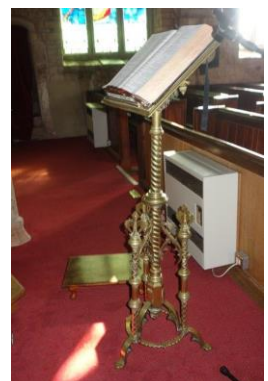
6.105

- **Component:** Brass lectern
- **Description:** Ornate gothic with barley twist central stand and three legs.
- **Condition:** Remains in good condition.
- **Repair Needed:** No action required at present time.

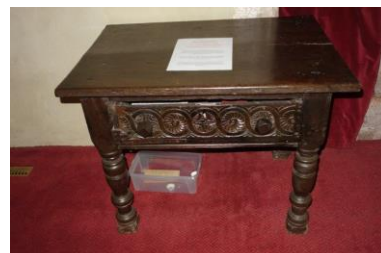
6.106

- **Component:** Table with drawer.
- **Description:** Positioned against the south aisle wall. 16th Century oak table
- **Condition:** Draw rails loose.
- **Repair Needed:** No Action required at present time.

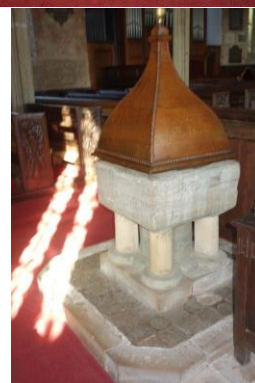
6.107

- **Component:** Font
- **Description:** Norman, four-sided, square bowl set on four stub columns supported on base. Interesting wooden font cover with gilded finial.
- **Condition:** Crack to font bowl, said to leak. Font cover refurbished since last inspection.
- **Repair Needed:** No Action required to font at present time.

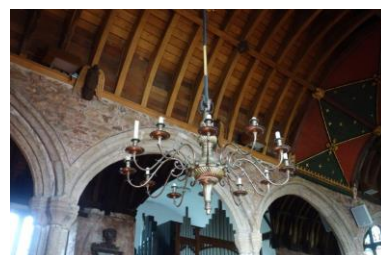
6.108

- **Component:** Brass candelabra.
- **Description:** 19th Century, hanging on a rod connected to a chain.
- **Condition:** Remains in good condition.
- **Repair Needed:** No Action required at present time.

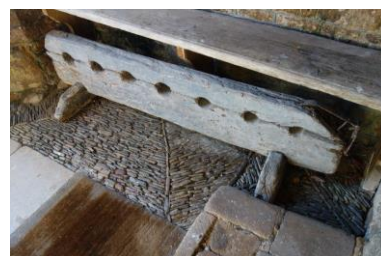
6.109

- **Component:** Stocks located within porch.
- **Description:** Oak stocks, with positions for seven limbs.
- **Condition:** Worn but reasonable.
- **Repair Needed:** No Action required at present time.

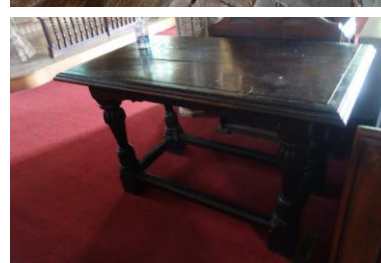
6.110

- **Component:** Table.
- **Description:** Oak 17th Century table with turned legs.
- **Condition:** Remained in sound condition.
- **Repair Needed:** No Action required at present time.

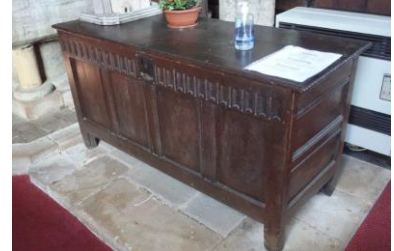
6.111

- **Component:** Oak coffer.
- **Description:** Oak 17th coffer with craved front panel.
- **Condition:** Remained in sound condition.
- **Repair Needed:** No Action required at present time.

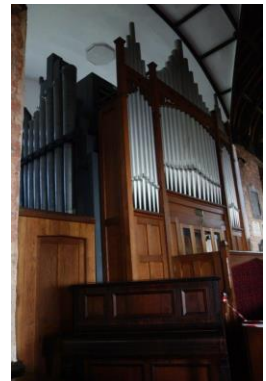
6.112

- **Component:** Pipe Organ.
- **Description:** Located within north transept, 19th century pipe organ.
- **Condition:** Appears well maintained,
- **Repair Needed:** No action required at present time.

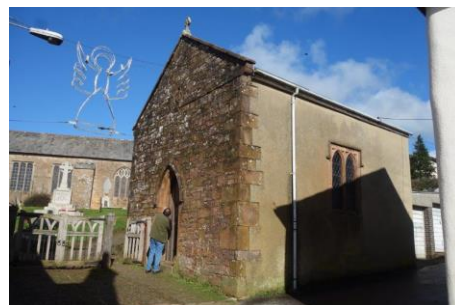
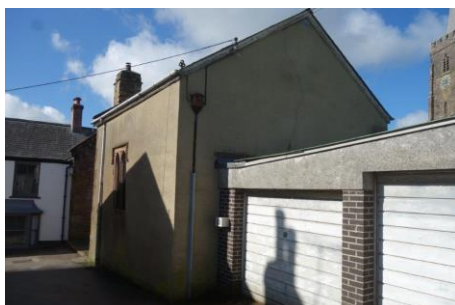
6.115 **Note:** Building Conservation Services drew up a schedule of repairs in coordination with structural repair firm, Helfix in December 2016. Prices were obtained to undertake the remedial repairs, but it would appear this work was never commissioned.

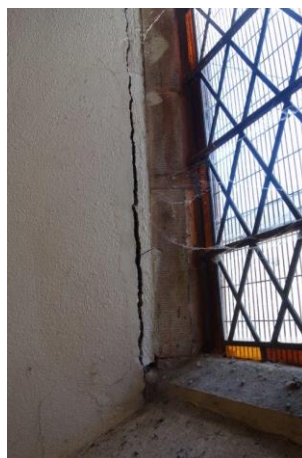
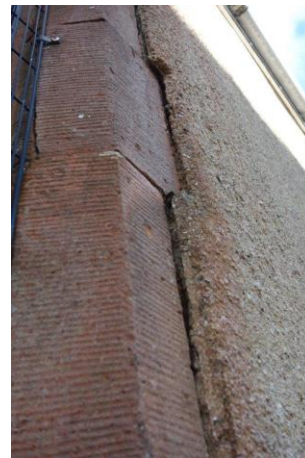
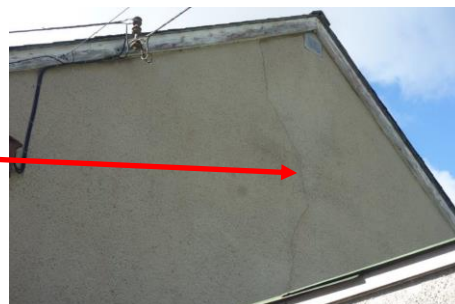
6.116

- **Component:** Detached Hall walls.
 - **Description:** Walls of roughly squared and coursed local stone with dressed quoins, repointed with cement. Other than the gabled west elevation all other elevations rendered with a thick layer of very hard course cement.

- **Condition of South Wall** - the front wall continues to bow outwards above and to the side of the two-light mullion window indicating structural movement, possibly the result of the flattening of the arch and the separating of the inner and outer masonry from the inner wall core. Internal cracking around the window jambs and soffit appears to have largely stabilised with little change since the previous quinquennial. The heavy cement render, however, has moved slightly further away from the masonry substrate and continues to threaten sudden collapse in to the street.

- Condition of East gable** - Full height vertical crack in the render around the former gable chimney stack may be structural or may only be as deep as the render. Removal of the render will determine the severity of this defect.

- **Repair Needed:** The building is suffering from structural movement and although it appears as if it remains static, some small movement continues and therefore there continues to be considerable risk that it may unexpectedly deteriorate very quickly. Structural strengthening works are required. In addition, the cement render is contributing to the ill-health of the building, trapping moisture within the unstable masonry, and therefore any programme of future repairs should also include the complete removal of the existing coat of cement render and the underlying masonry substrate repointed or re-rendered with lime.

- **Component:** Detached Hall walls.
- **Repair Needed:** The building is suffering from structural movement and although it appears as if it remains static, some small movement continues and therefore there continues to be considerable risk that it may unexpectable deteriorate very quickly. Structural strengthening works are required. In addition, the cement render is contributing to the ill-health of the building, trapping moisture within the unstable masonry, and therefore any programme of future repairs should also include the complete removal of the existing coat of cement render and the underlying masonry substrate repointed or re-rendered with lime.

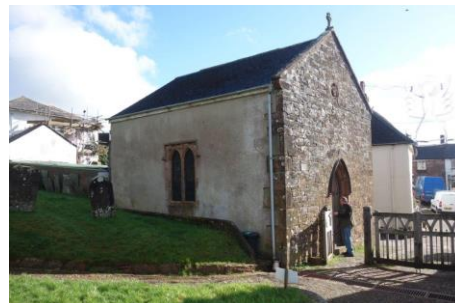
- **Condition of North Wall** – the thick layer of dense cement render applied over the masonry cracking at the corners of building and around the window opening. Cracking probably largely the result of thermal expansion and contraction of the render. Some cracking around the edge of the internal window jambs however indicates that there is some underlying structural movement, similar to the front elevation.

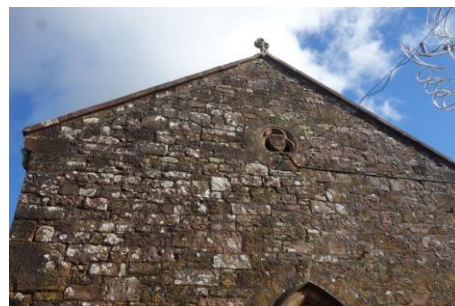
- **Condition of West Gable** – roughly dressed and coursed stone bedded on lime mortar, repointed with cement. Sight cracking to stonework over doorway associated with settlement of arch appears to have largely stabilised. Cracking through internal render possibly also associated with structural settlement in this area.

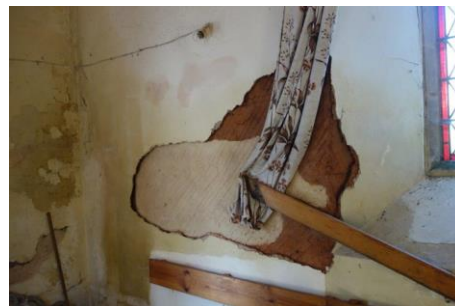
6.121

- **Component:** Detached Hall – Internal Walls.
- **Description:** A mixture of deferent plasters and repairs.
- **Condition:** A lot of cracking, popped and hollow plaster internally. Progressively getting worse. Possibly underlying structural problems, as noted above. Walls damp, probably due to the cracked external cement render allowing wind driven rain water in to the wall and inhibiting the drying out process.
- **Repair Needed:** Walls to be stripped back to stone and re-plastered with a lime putty plaster, on completion the external repair and re-rendering works.

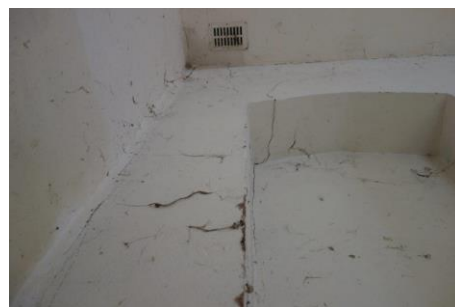
6.122

- **Component:** Detached Hall – Chimney stack.
- **Description:** Redundant chimney flue – stack taken down below eaves.
- **Condition:** Unvented. Slight cracking to internal plastered reveals and cracking to external render may be a result of some structural settlement around the stack. Removal of plaster and render will determine the severity of this defect.
- **Repair Needed:** Provided vent within former fireplace.

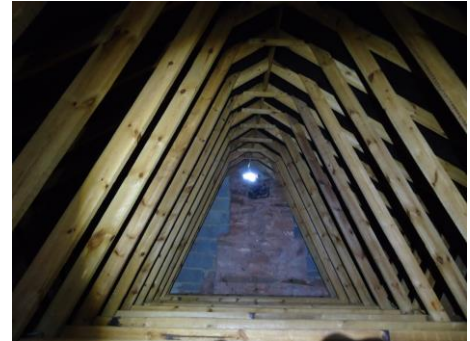
6.123

- **Component:** Detached Hall – Roof structure
- **Description:** Modern common rafter roof.
- **Condition:** Jackdaws and bats roosting in the roof space, otherwise appeared sound.
- **Repair Needed:** No action required at present time.

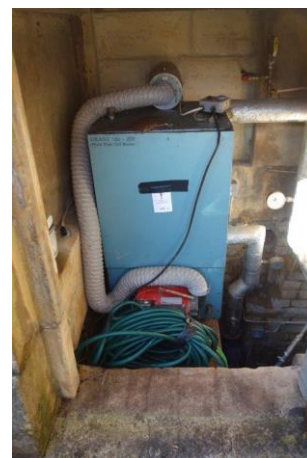
7.1

- **Component:** Heating System
- **Description:** Oil fired Grant 160-200 multi pass boiler housed within boiler room to west of south aisle. Previously partially submerged in water – now dry. Pressure cylinder below boiler. Pipework leads into subterranean service duct that runs under the church serving electric fan assisted panel radiators. Double bunded plastic oil tank located adjacent boiler room.
- **Condition:** Recently upgraded radiators appear to be effective at warming the interior of the church. Water ingress causing corrosion to base of pressure cylinder. Last serviced 26th October 2020 by Mr P Hawkins.
- **Repair Needed:** Ensure periodical service undertaken.

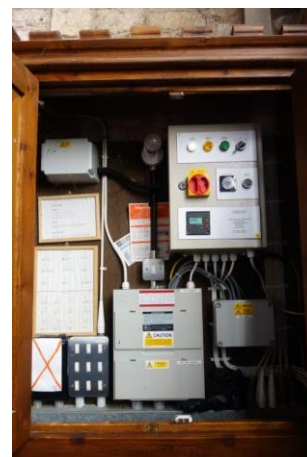
7.2

- **Component:** Main Electrical circuits.
- **Description:** Modern fuse box and miniature circuit breakers serving main body of church located in cupboard to left hand side of south entrance. Large internal flood lights provide light to main body of the church. Separate lighting circuits provided for tower and north transept. Modern metal clad switches and sockets on separate socket circuits. Separate heating circuits.
- **Condition:** Fuse box, lighting and socket circuits all appeared to be a relatively new installation. Fuse box, lighting and socket circuits all appeared to be a relatively new installation. 5 year periodical electrical test undertaken by W J Marris & Son 29 April 2018.
- **Repair Needed:** Ensure periodical testing undertaken as required.

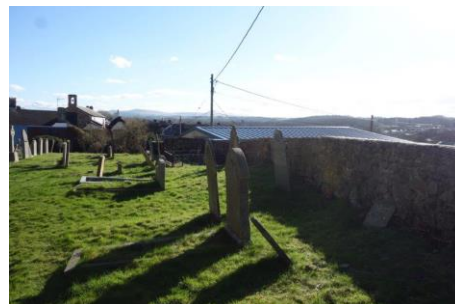
8.7

- **Component:** West Boundary
- **Description:** Western boundary formed by a tall stone retaining wall, neighbouring a number of commercial and agricultural buildings. Access from neighbouring properties restricted.
- **Condition:** The wall was largely covered with ivy on both sides and therefore its condition could not be verified.
- **Repair Needed:** Ownership and liability for maintenance of this wall should be established. The risk of falling masonry on to neighbouring properties is an issue. Ongoing repairs are likely to be required.

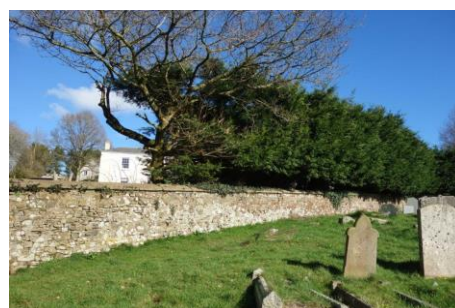
8.9

- **Component:** East Boundary
- **Description:** Eastern boundary formed partly of a 1.5m high stone wall with rounded concrete coping and partly from hedging.
- **Condition:** Many loose stone and washed-out mortar, ivy growth and cracking to the coping stones.

- **Repair Needed:** Requires ivy removal, repairs and repointing.

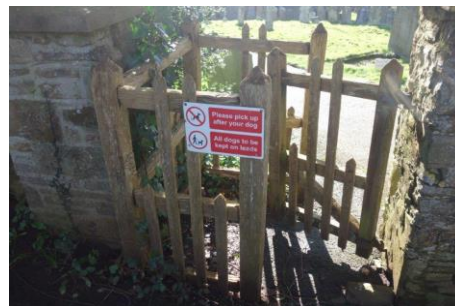
8.10

- **Component:** East gate.
- **Description:** Three stone masonry pillars supporting double width timber gate and timber kissing gate.
- **Condition:** Both gates very fragile with loose joints and rotten supporting posts.
- **Repair Needed:** Rotten posts ends require replacing and gates refurbishing. The gates and posts have a very pleasing worn aesthetic and retention of as much original timber should be attempted.

- **Component:** East gate.
- **Repair Needed:** Rotten posts ends require replacing and gates refurbishing. The gates and posts have a very pleasing worn aesthetic and retention of as much original timber should be attempted.

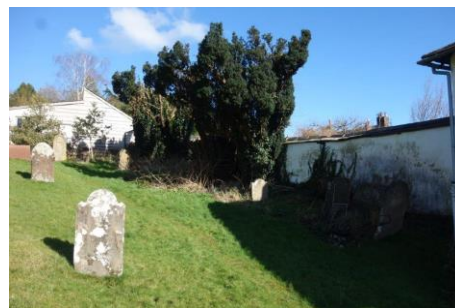
8.11

- **Component:** South boundary.
- **Description:** South boundary defined by the rear, north walls of a terrace of buildings comprised of Church House, a single storey blockwork garages and the Vestry/Sunday school building. Yew trees reduced sight last inspection.
- **Condition:** Garden wall behind yew trees in poor condition.
- **Repair Needed:** The question of who is responsible for maintenance of garden walls and hedges on the church boundary should be established.

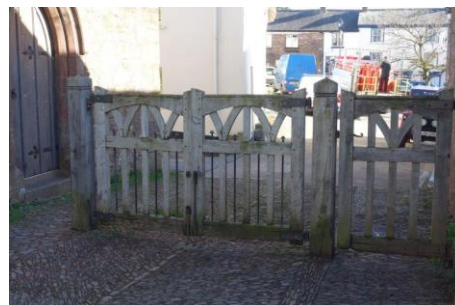
8.12

- **Component:** South gate.
- **Description:** Set of four timber gates supported on timber posts spanning between the Vestry/Sunday School building and neighbouring building.
- **Condition:** The base of the posts slowly decaying, as was the bottom rail of the two gates at each extreme, although likely to remain serviceable for a while longer.
- **Repair Needed:** No action required at present time.

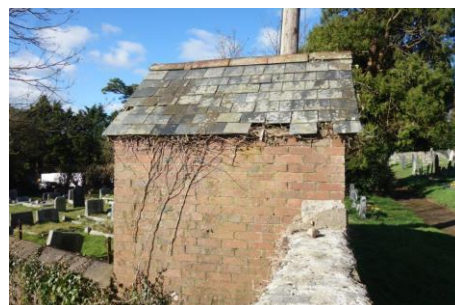
8.13

- **Component:** Small shed – mortuary?
- **Description:** Rectangular brick structure built in to the western boundary wall. Slate roof, timber door.
- **Condition:** Slates missing from roof and door in need of refurbishment.
- **Repair Needed:** Replace missing and slipped slates and redecorate door.
